# VILLAGE OF MENANDS

## ADA PUBLIC STREETS AND SIDEWALKS PLAN

March 2025

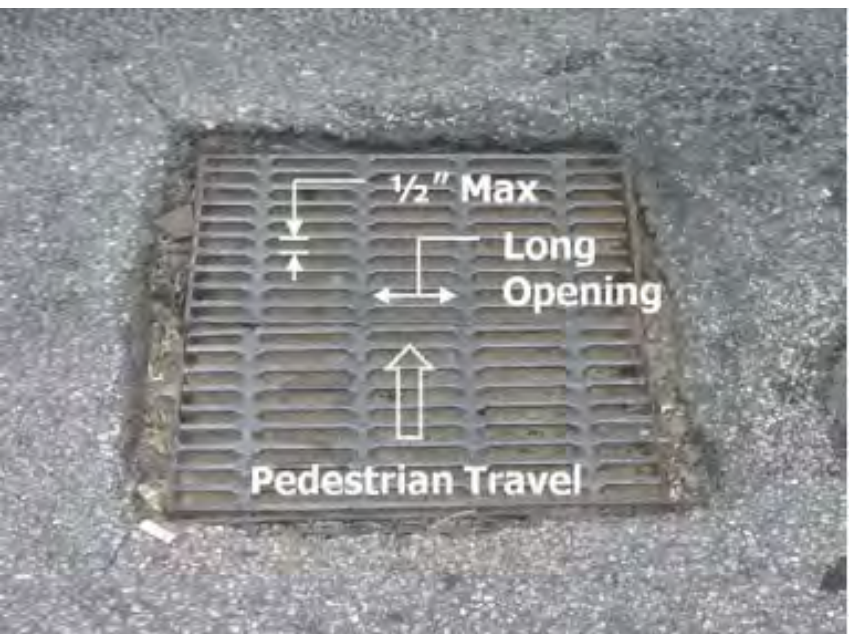
| <p><i>Grate in Pathway:</i></p> <p>If a grate is incorporated into a pathway, the holes in the grate should be no larger than ½ inch in diameter.</p> | <p>The photograph shows a square metal grate set into a gravel surface. Annotations include: '½" Max' with a vertical arrow pointing to the gap between grate bars; 'Long Opening' with a horizontal double-headed arrow indicating the length of the rectangular openings; and 'Pedestrian Travel' with a white arrow pointing upwards through the center of the grate.</p> |

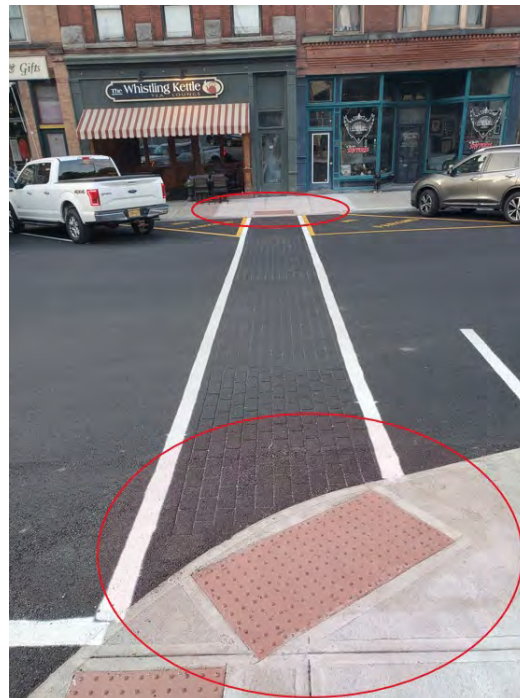
While often marked, it is not required. The location of a curb ramp on both sides' makes a complete pedestrian access route. If there is a curb ramp on one side and not the other, then the path is considered inaccessible.

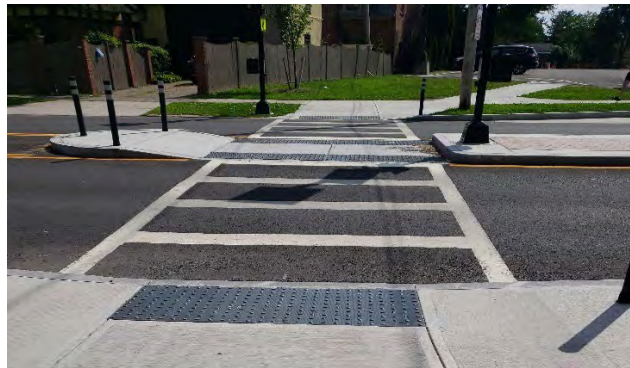
An area within an intersection where people wait for a break in traffic to safely cross the remainder of the intersection. Curb ramps in refuge islands must meet all the accessibility criteria of curb ramps not in refuge islands.

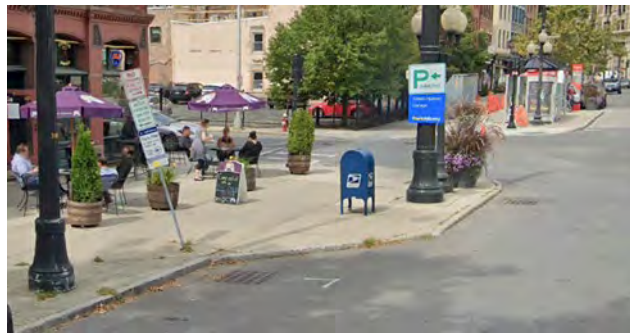
Curb extensions, also known as bulb-outs or bump outs, provide a clear view of oncoming traffic prior to leaving the sidewalk. Curb ramps on curb extensions must meet all accessibility criteria of curb ramps not on extensions.

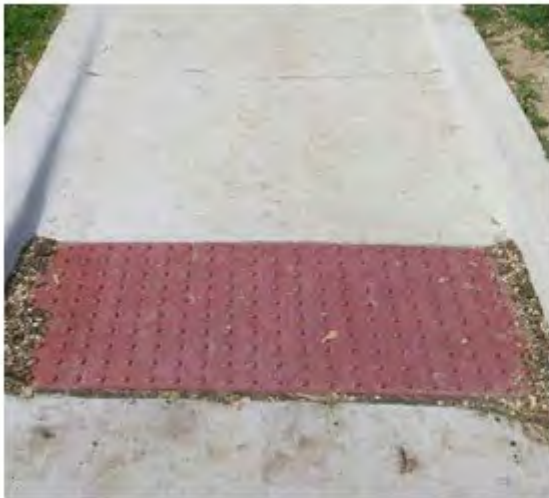
*Truncated domes*

**Truncated Domes:** Elevated, bubble-like domes on the surface of the DWS. The domes should have an approximate height of 0.2 (1/5<sup>th</sup>) inches. The domes should face the same direction as the sidewalk.

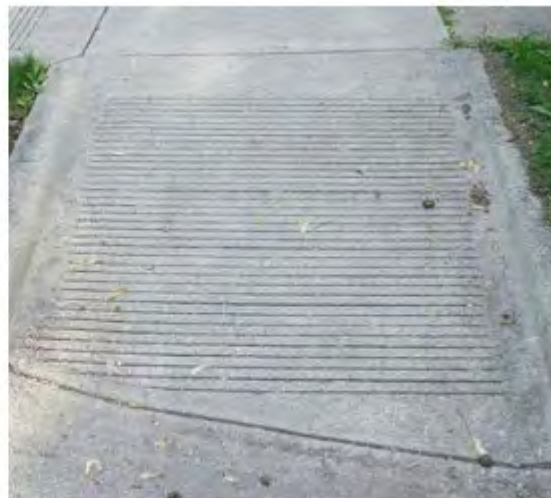
*Pavement grooves*

**Pavement Grooves:** Grooves cut into the existing concrete, facing the same direction as the sidewalk. Pavement grooves are common but are not recognized as an acceptable DWS type because they do not provide a visual contrast between the pavement and ramp.

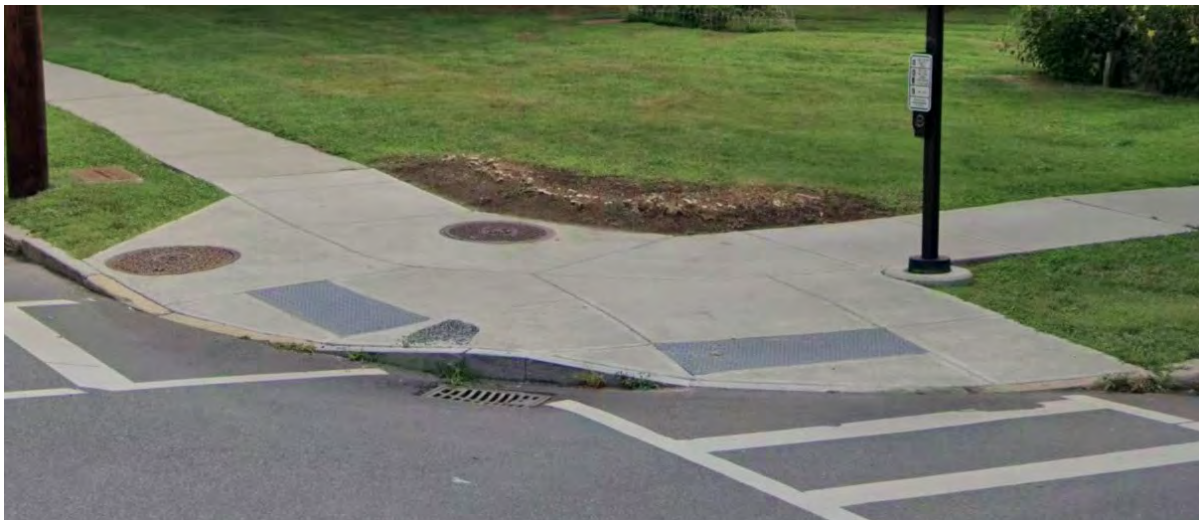
**Depth:** The DWS should be a minimum of 2 feet (24 inches) deep, in the direction of travel.

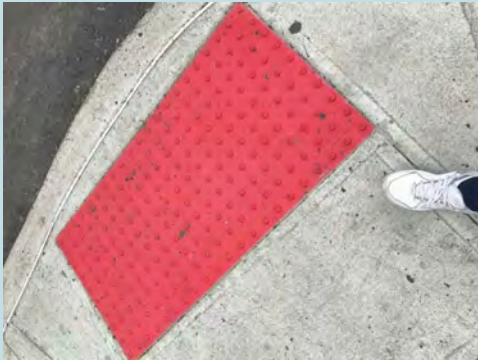
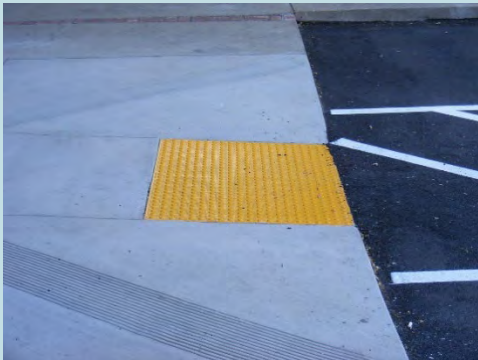
**DWS IS NOT  
SIGNIFICANTLY  
DETERIORATED**

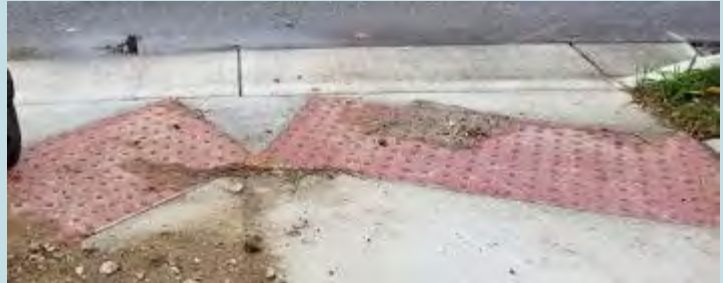
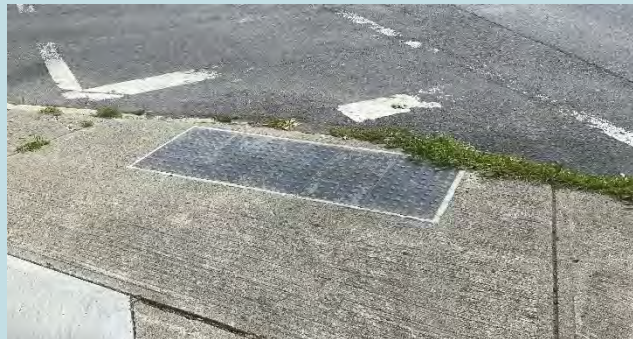
**DWS IS SIGNIFICANTLY  
DETERIORATED**

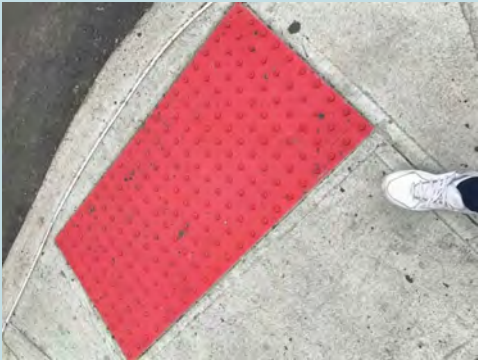
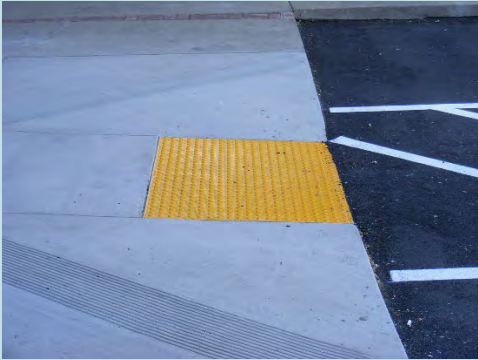
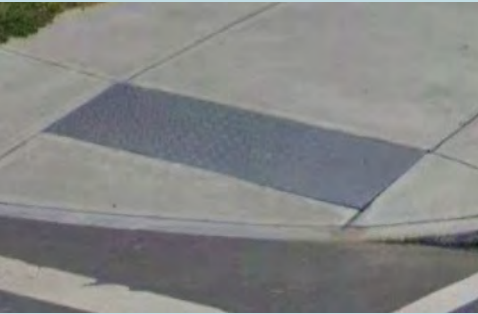
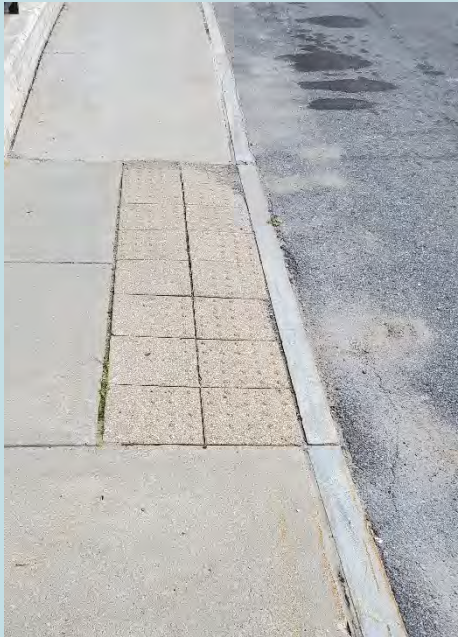
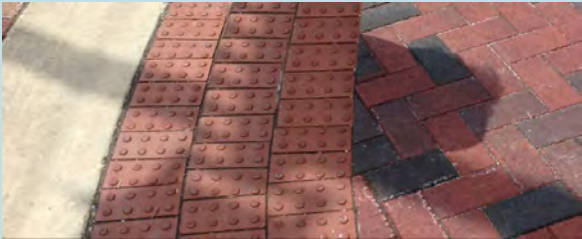
- The color should contrast from the sidewalk, it should at least be light-on-dark or dark-on-light.
- Best practices is to install a yellow DWS (as seen on bottom left image) as it is the most visible for the vision impaired, darker colors often appear as missing gaps in the sidewalk.

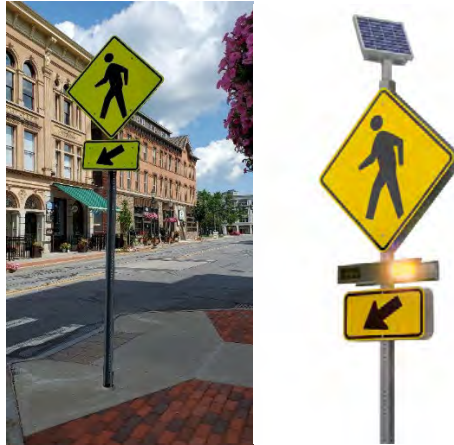
**Pedestrian Sign – Not pedestrian activated:** A sign marked for pedestrian crossing without a button to press. It may or may not have flashing lights.

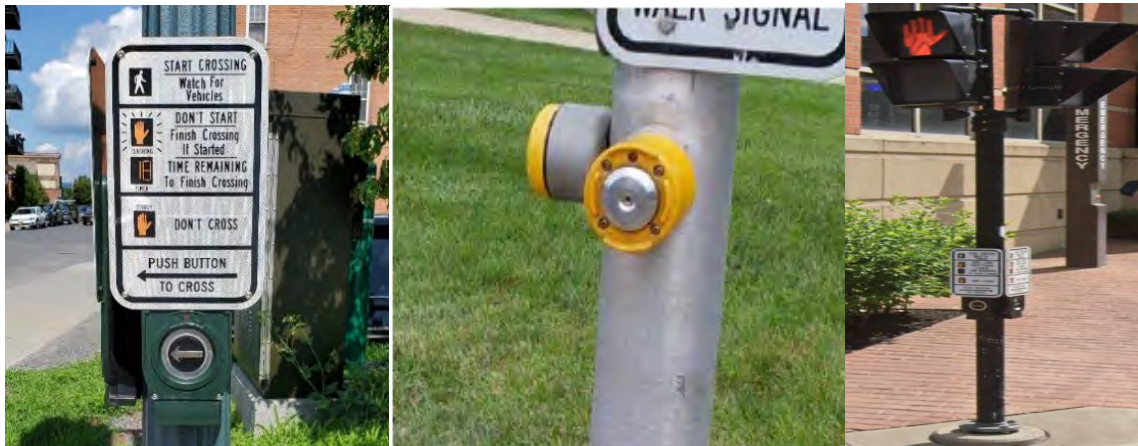
**Pedestrian Signal – Pedestrian activated:** A button pushed by the pedestrian, which activates a crossing signal. It may or may not have a flashing light.

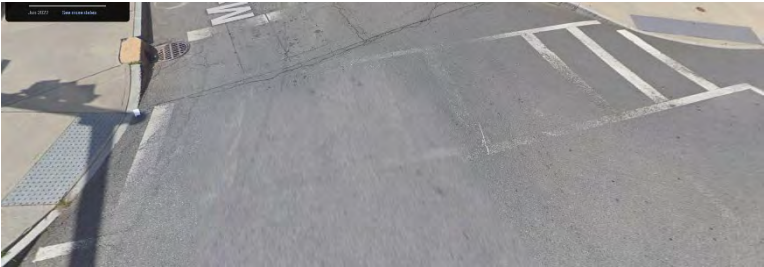
| Rating | Condition | Reference Images |
|---|---|---|
| Poor | Crosswalk is heavily faded, completely faded, or missing sections. | |

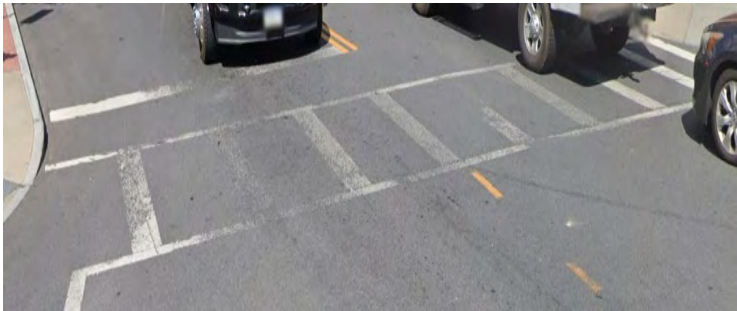
| Rating | Condition | Reference Images |
|---|---|---|
| Fair | Crosswalk is fading but still visible. | |

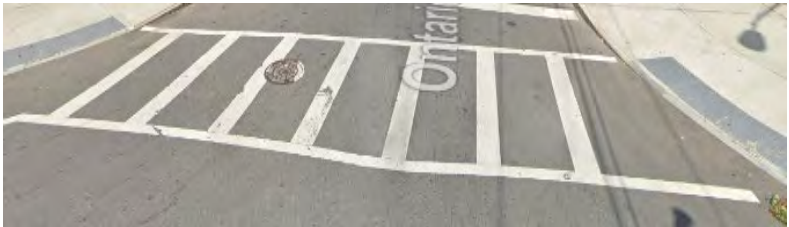
| Rating | Condition | Reference Images |
|---|---|---|
| Good | Crosswalk is in like-new condition with minor cracks. | |

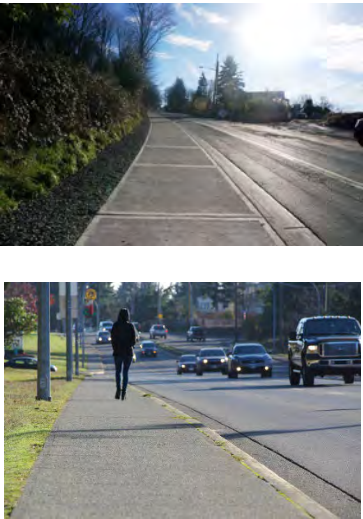
| Rating | Condition | Reference Images |
|---|---|---|
| Fully Accessible | <ul style="list-style-type: none"> <li>Sidewalk is new or in like-new condition.</li> <li>Sidewalk is level, no cracks, no faults, no obstructions, and adequate width.</li> <li>Sidewalk is at least 4 feet (48 inches) wide.</li> </ul> | |

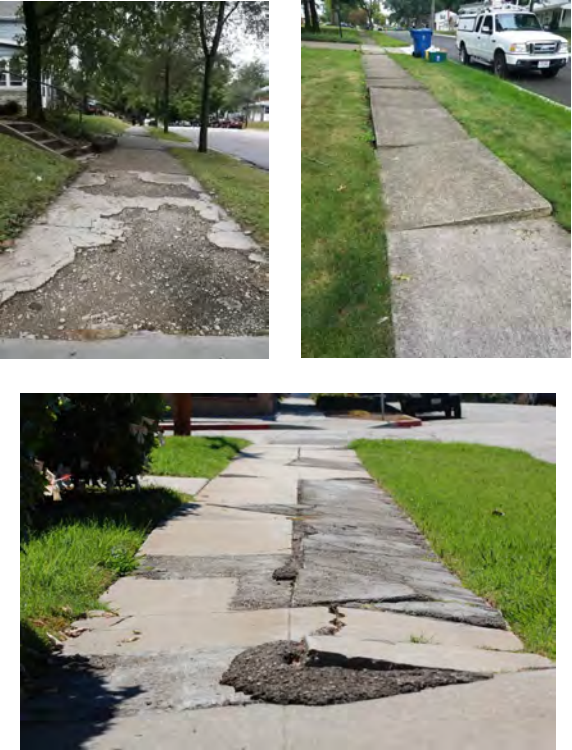
| <p>Not Accessible</p> | <ul style="list-style-type: none"> <li>• Sidewalk may have serious accumulation of dirt/debris, establishment of vegetation or other obstructions.</li> <li>• Sidewalk is uneven from faulting (greater than ½ inch) that cannot be grind down/repaired and will require replacement.</li> <li>• Sidewalk is less than 4 feet wide.</li> </ul> | |

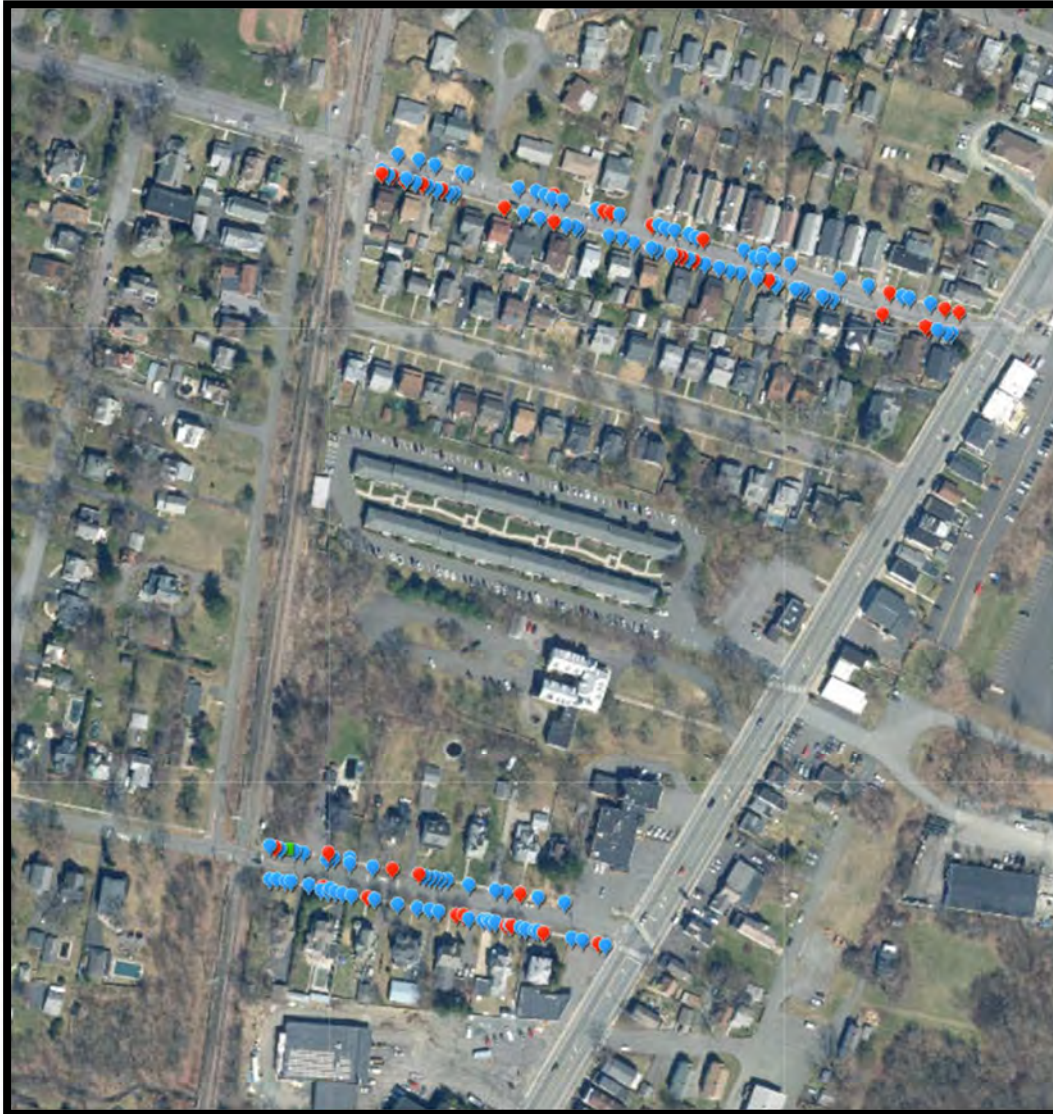
**RISK ASSESSMENT HAZARD LOCATIONS  
VILLAGE OF MENANDS  
280 BROADWAY, MENANDS, NY 12204**

📍 – VHD 1" to 2½" (Red)

📍 – ADA Access

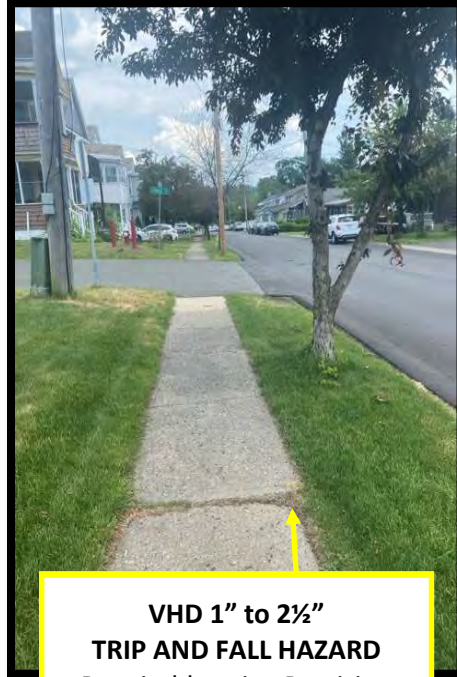
**VHD 1" to 2½"**  
**TRIP AND FALL HAZARD**  
Repairable using Precision  
Concrete Cutting Process

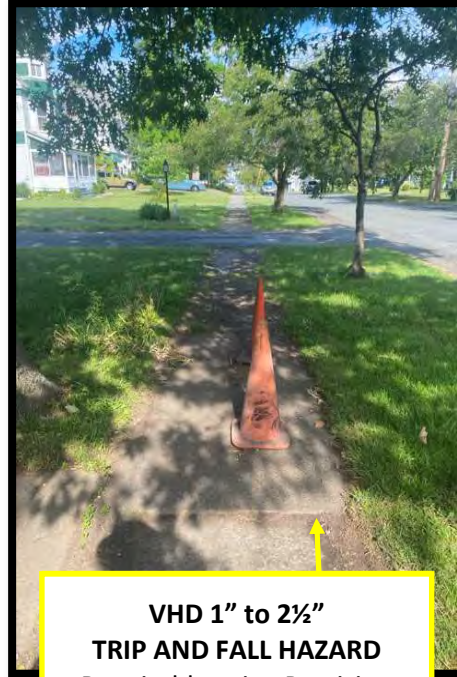
**VHD 1" to 2½"**  
**TRIP AND FALL HAZARD**  
Repairable using Precision  
Concrete Cutting Process

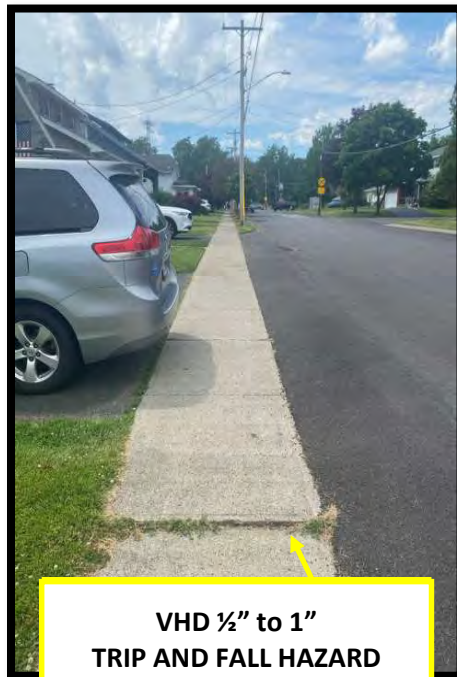
**VHD ½" to 1"**  
**TRIP AND FALL HAZARD**  
Repairable using Precision  
Concrete Cutting Process

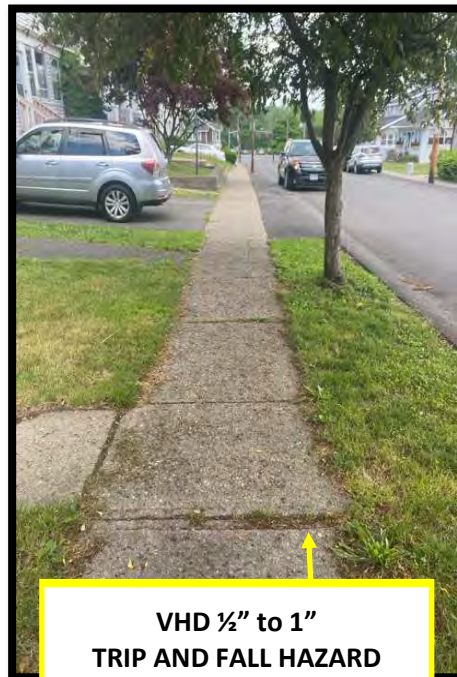
**VHD ½" to 1"**  
**TRIP AND FALL HAZARD**  
Repairable using Precision  
Concrete Cutting Process

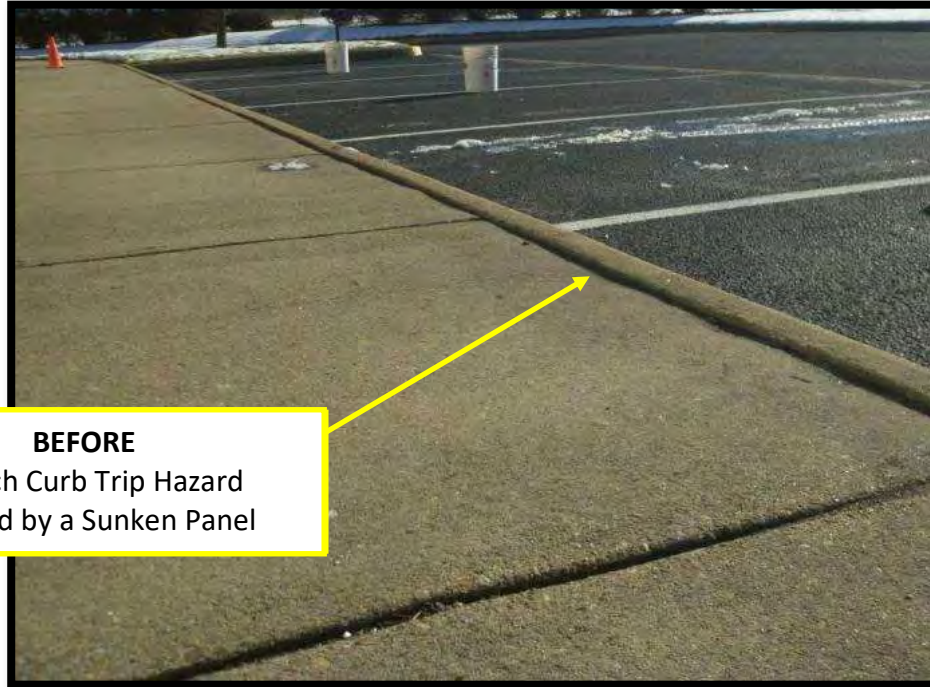
### BEFORE

1+ Inch Curb Trip Hazard  
Created by a Sunken Panel

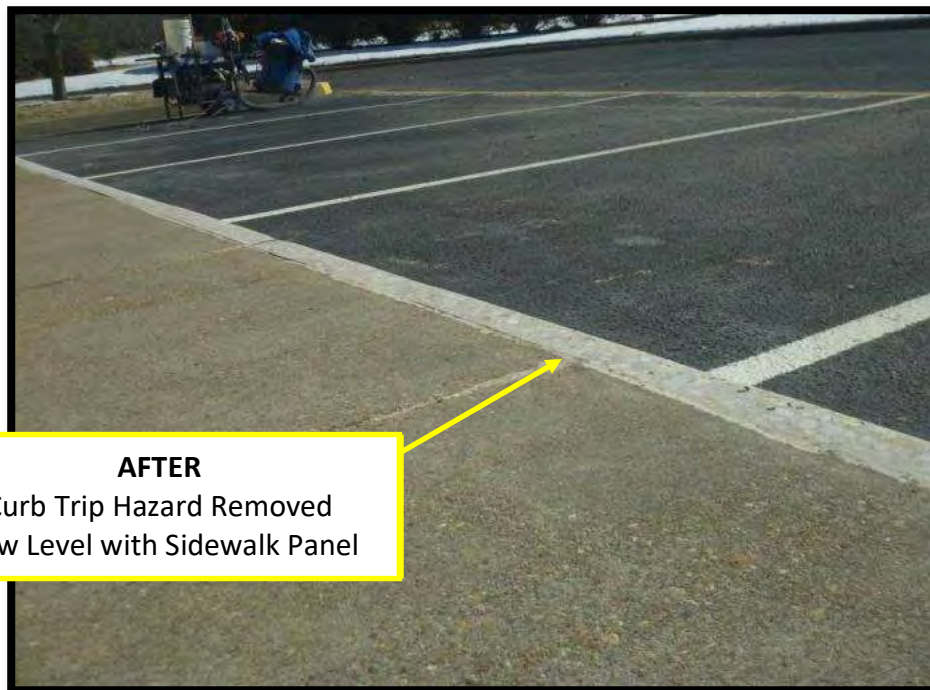
### AFTER

Curb Trip Hazard Removed  
Now Level with Sidewalk Panel
