TOWN OF  
CLIFTON PARK  
ADA TRANSITION  
PLAN

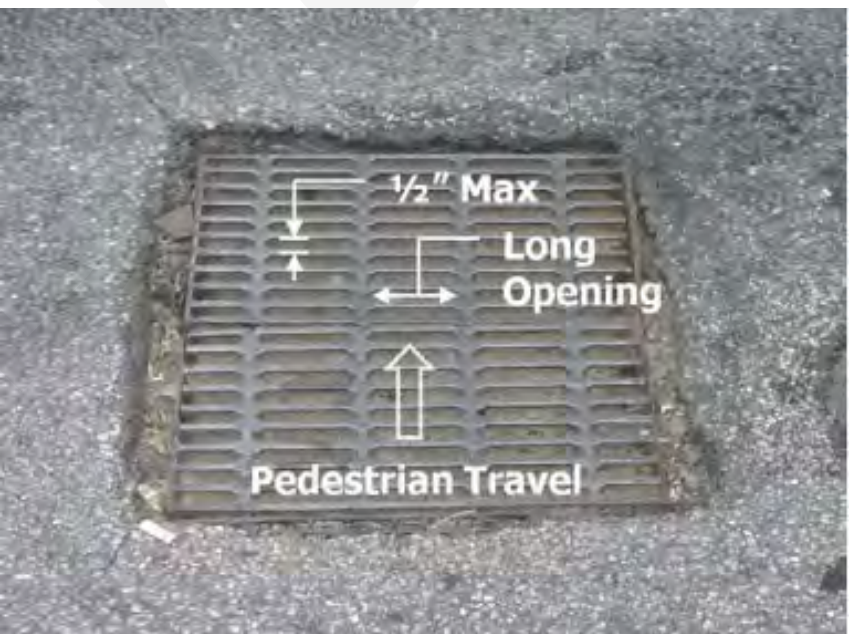
| <p><i>Grate in Pathway:</i></p> <p>If a grate is incorporated into a pathway, the holes in the grate should be no larger than ½ inch in diameter.</p> | <p>The photograph shows a square metal grate set into a paved surface. Annotations include: '1/2" Max' pointing to the height of the grate's openings, 'Long Opening' pointing to the length of the rectangular holes, and 'Pedestrian Travel' with an arrow pointing in the direction of travel across the grate.</p> |

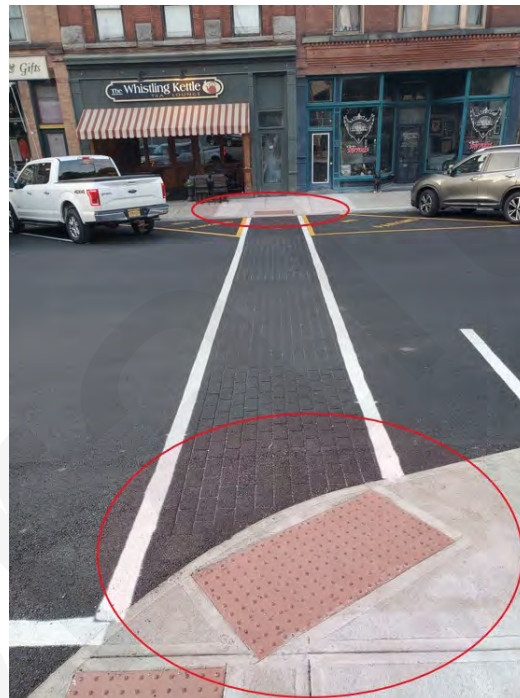
### *Street Crossings:*

While often marked, it is not required. The location of a curb ramp on both sides' makes a complete pedestrian access route. If there is a curb ramp on one side and not the other, then the path is considered inaccessible.

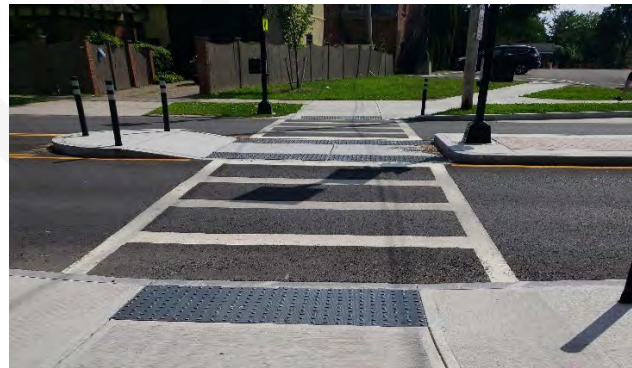
### *Pedestrian Refuge Island:*

An area within an intersection where people wait for a break in traffic to safely cross the remainder of the intersection. Curb ramps in refuge islands must meet all the accessibility criteria of curb ramps not in refuge islands.

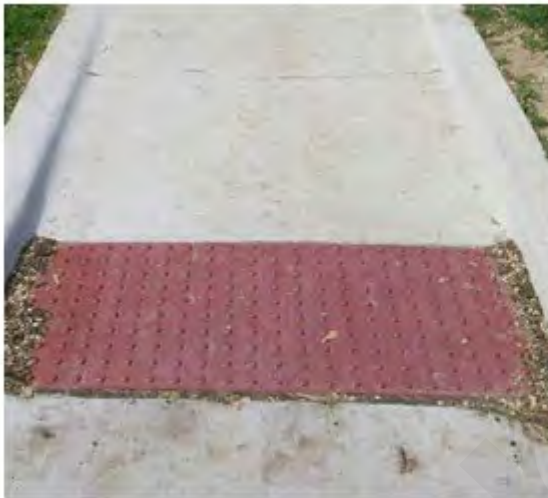
Truncated domes

**Truncated Domes:** Elevated, bubble-like domes on the surface of the DWS. The domes should have an approximate height of 0.2 (1/5<sup>th</sup>) inches. The domes should face the same direction as the sidewalk.

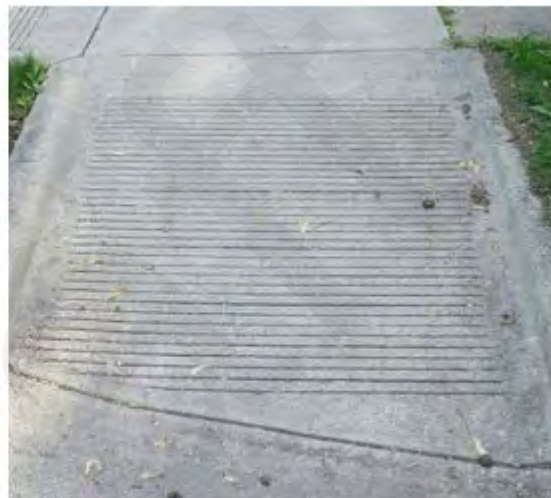
**Pavement Grooves:** Grooves cut into the existing concrete, facing the same direction as the sidewalk. Pavement grooves are common but are not recognized as an acceptable DWS type because they do not provide a visual contrast between the pavement and ramp.

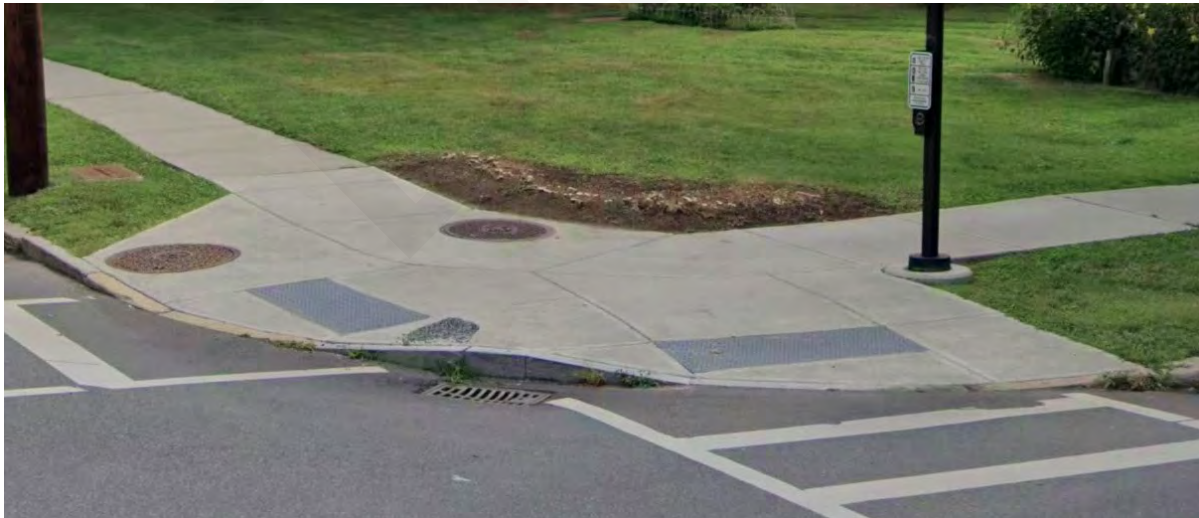
**Width:** The DWS should extend the full width of the curb ramp or sidewalk. The minimum width is 4 feet (48 inches).

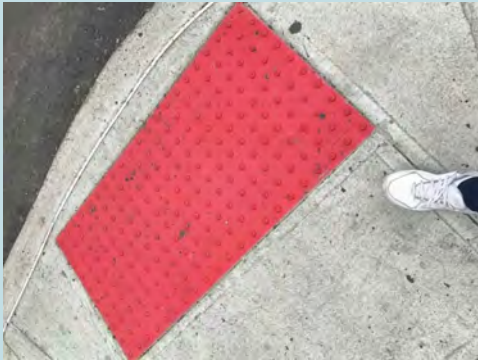
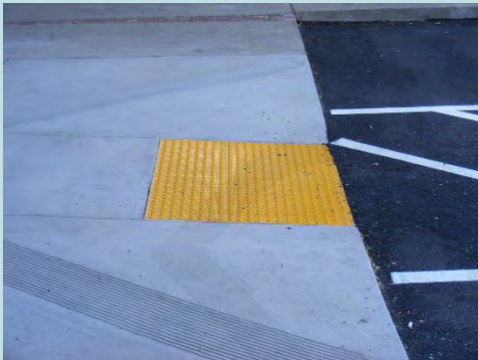
**Deterioration:** The DWS should be extruding from the surface so that visually impaired individuals will feel the strip.

**DWS IS NOT  
SIGNIFICANTLY  
DETERIORATED**

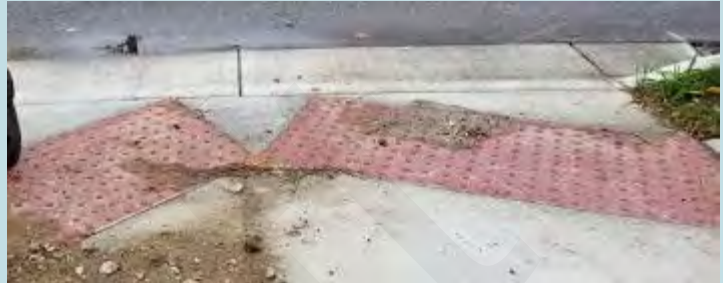
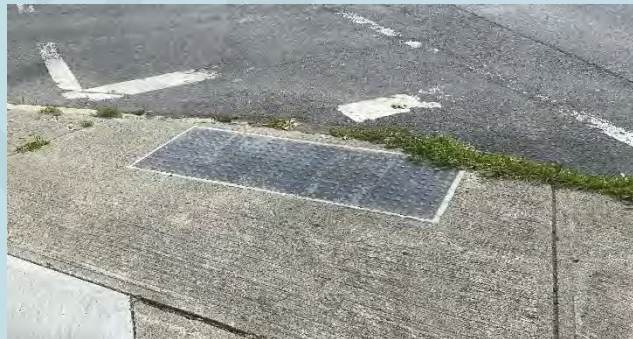
**DWS IS SIGNIFICANTLY  
DETERIORATED**

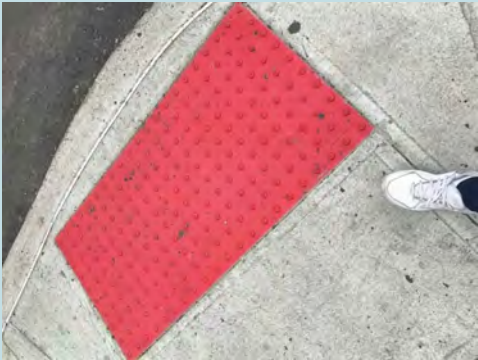
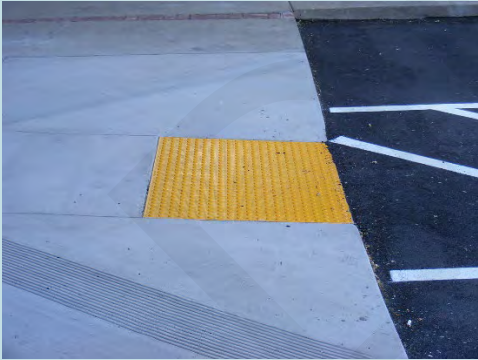
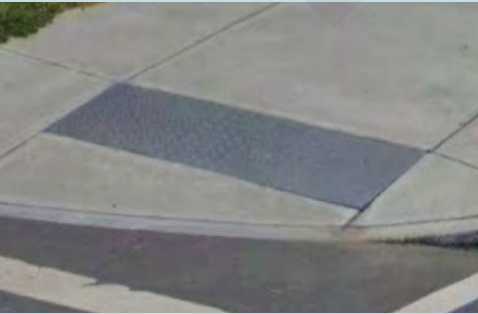
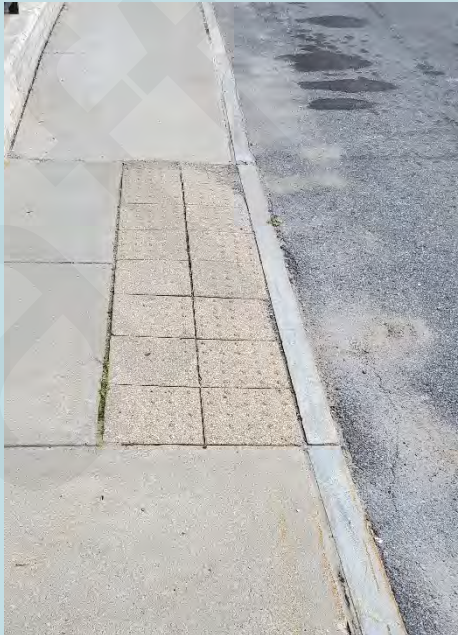
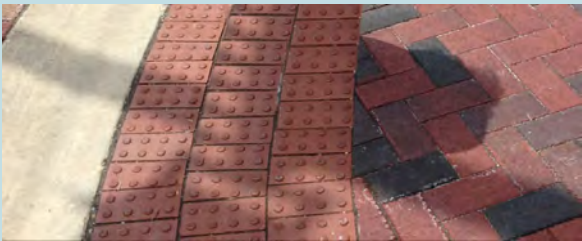
- The color should contrast from the sidewalk, it should at least be light-on-dark or dark-on-light.
- Best practices is to install a yellow DWS (as seen on bottom left image) as it is the most visible for the vision impaired, darker colors often appear as missing gaps in the sidewalk.

| DWS COLOR CONTRASTS FROM CURB RAMP | DWS COLOR DOES NOT CONTRAST FROM CURB RAMP |

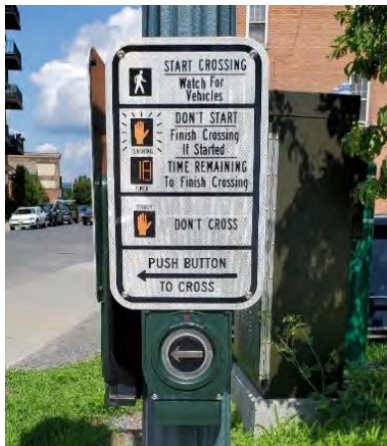
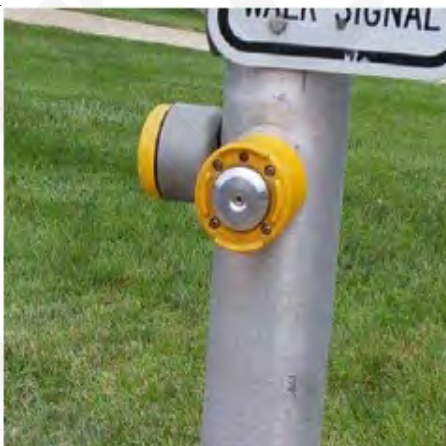
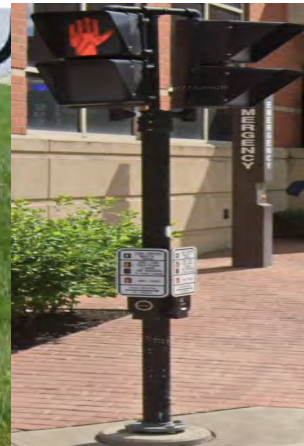
**Pedestrian Signal – Pedestrian activated:** A button pushed by the pedestrian, which activates a crossing signal. It may or may not have a flashing light.

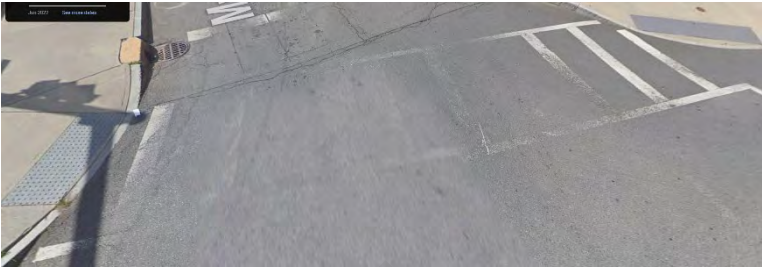
| Rating | Condition | Reference Images |
|---|---|---|
| Poor | Crosswalk is heavily faded, completely faded, or missing sections. | |

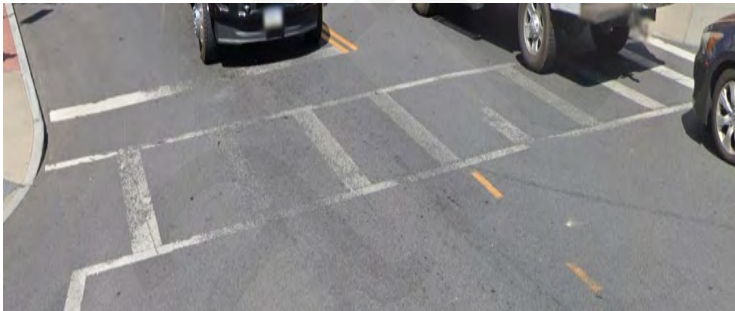
| Rating | Condition | Reference Images |
|---|---|---|
| Fair | Crosswalk is fading but still visible. | |

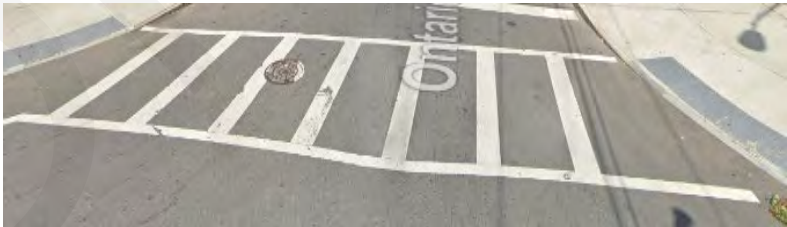
| Rating | Condition | Reference Images |
|---|---|---|
| Good | Crosswalk is in like-new condition with minor cracks. | |

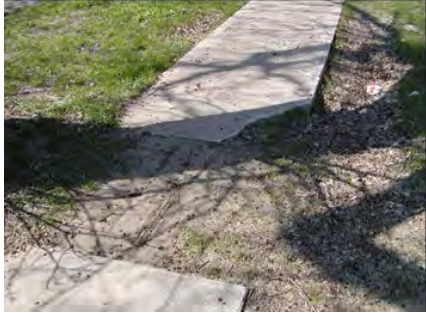
Missing Panels

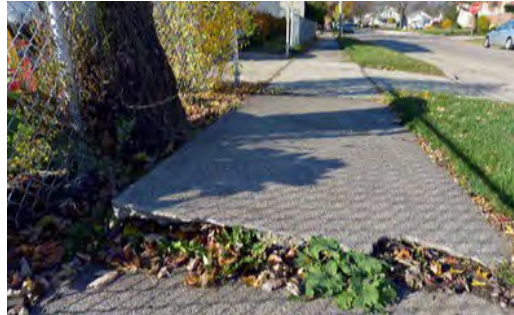
Heaving Panels

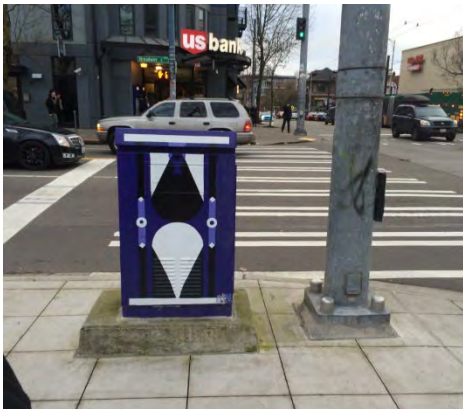
Obstructions

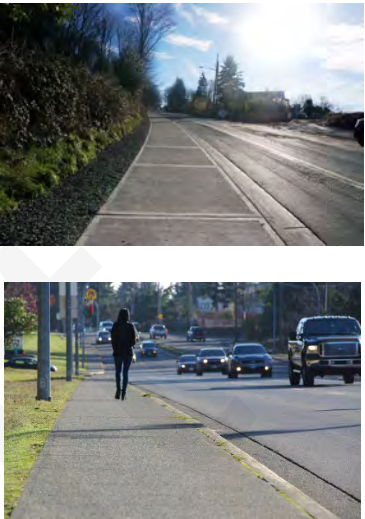
| Rating | Condition | Reference Images |
|---|---|---|
| Fully Accessible | <ul style="list-style-type: none"> <li>Sidewalk is new or in like-new condition.</li> <li>Sidewalk is level, no cracks, no faults, no obstructions, and adequate width.</li> <li>Sidewalk is at least 4 feet (48 inches) wide.</li> </ul> | |

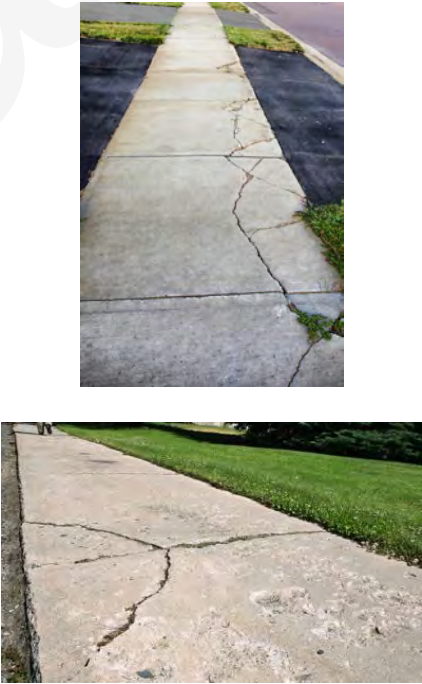
| Rating | Condition | Reference Images |
|---|---|---|
| Mostly Accessible | <ul style="list-style-type: none"> <li>Sidewalk is in almost new or good condition.</li> <li>Sidewalk is level and may have minor cracks.</li> <li>Sidewalk is at least 4 feet (48 inches) wide.</li> </ul> | |

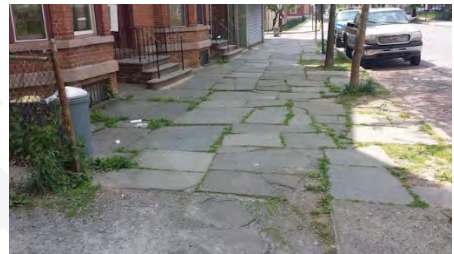
Partially  
Accessible

- Small patches of broken or chipped sidewalk, and a small buildup of dirt/debris, vegetation growing between panels or cracks.
- Sidewalk may have small vertical faults larger than  $\frac{1}{2}$  inch but could potentially be grind down/repaired.
- Large cracks are present.
- Sidewalk is less than 4 feet wide.

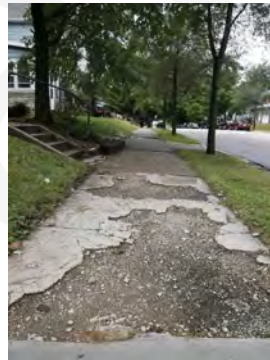
Not  
Accessible

- Sidewalk may have serious accumulation of dirt/debris, establishment of vegetation or other obstructions.
- Sidewalk is uneven from faulting (greater than  $\frac{1}{2}$  inch) that cannot be grind down/repaired and will require replacement.
- Sidewalk is less than 4 feet wide.
